ieema journal

VOL 16 • ISSUE NO. 1 • SEPTEMBER 2024

Transformer Bushings

Understanding the phenomena of 'negative tan delta' and its simulation through experiments

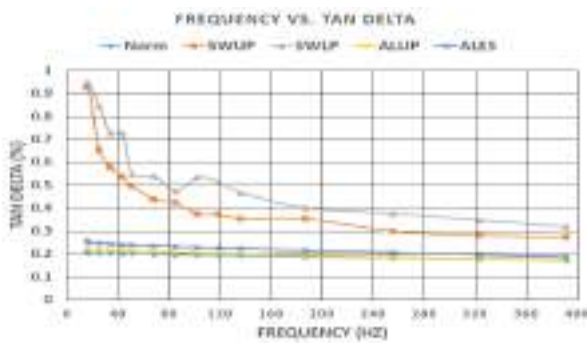
Tan delta vs frequency are plotted individually for all three bushings. Tan delta curves include: normal condition (norm), saltwater upper side (SWUP), salt water lower side (SWLP), aluminium foil wrapping upper side (ALUP), aluminium foil wrapping entire side (ALES).

Figure 10: Bushing-1 tan delta results

- Bushing-1 and bushing-2 show similar patterns of results, ie, at lower frequencies, the saltwater spraying abnormally increased tan delta at 15 Hz.
- Bushing-3 showed negative tan delta values at 15 Hz and 17 Hz in saltwater spraying condition. This was accompanied by reduced capacitance values, thus confirming significantly low resistance path by saltwater spraying.

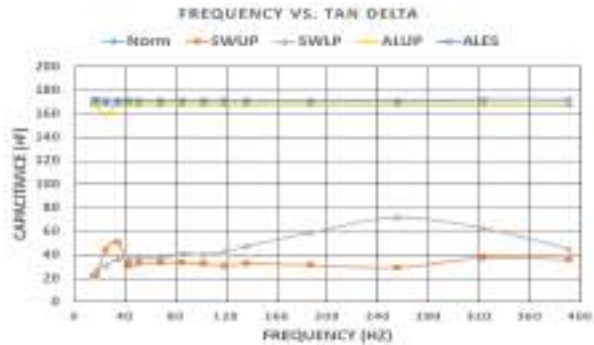
Figure 13: Bushing-3 capacitance results
